TECHNICAL SERVICE BULLETIN

75-D-6

SELECTOR SHAFT YOKE PLASTIC BUSH
WORKING LOOSE

SPITFIRE 1500 & TR7

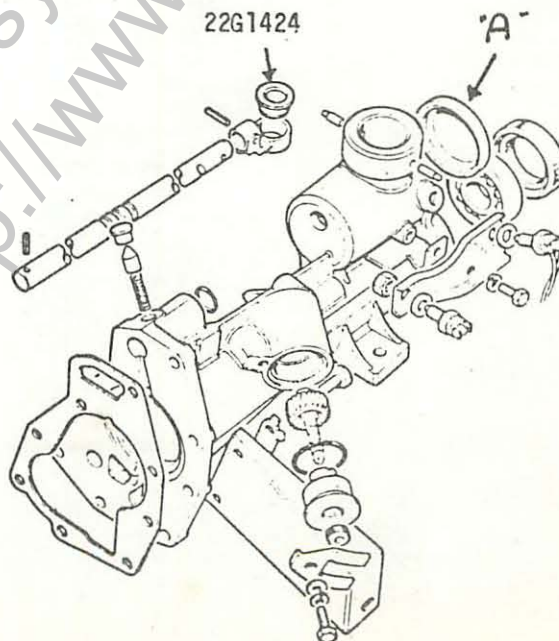
Complaints have been received of the plastic bush, Part No. 22G1424 which is located at the rear end of the single rail selector shaft in the selector shaft yoke directly under the gear lever working loose in service.

To obtain access to the gear lever housing to support the yoke, the large welch plug at the rear of the housing must be removed. (Item A on diagram). It is essential that the bore in the yoke and exterior of the plastic bush are thoroughly clean and free from oil before applying Loctite 636.

Where this occurs, a satisfactory repair can be carried out using Loctite 636 to secure the bush in the yoke. (Please note that Loctite 636 specification must be strictly observed).

Owing to the the yoke being a cast component, it must be supported when tapping the plastic bush back into position to avoid possible fractures.
