# TECHNICAL SERVICE BULLETIN

76-A-11

AUTOMATIC CHOKE ASSEMBLY

TR7  
CALIFORNIA SPEC. ONLY

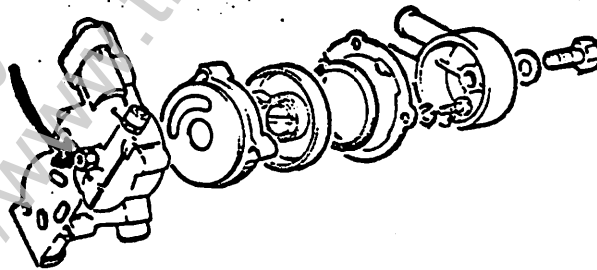
Instances have been reported where the automatic choke assembly works loose in service, rendering the carburetter inoperative or in some cases, allowing it to operate at full rich position.

The inner choke mechanism is secured by a brass nut located at the back of the choke assembly (refer to diagram). It is suggested that this nut be checked for proper security during PDI, and at the same time make sure that all mounting screws are tightened thoroughly.
