Triumph TR7 TR8 Clock Repair

Greg Bober, Copyright 10 January 2008, Rev 2.5 (originally written 4 July 2005)

Abstract

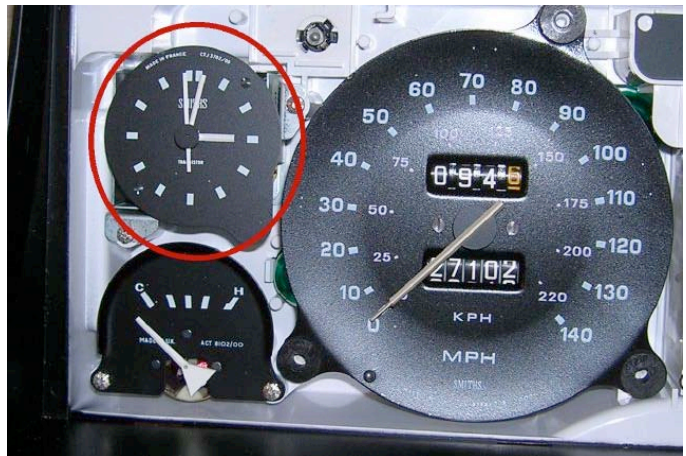
Picture 1: The TR7/TR8 clock in instrument cluster

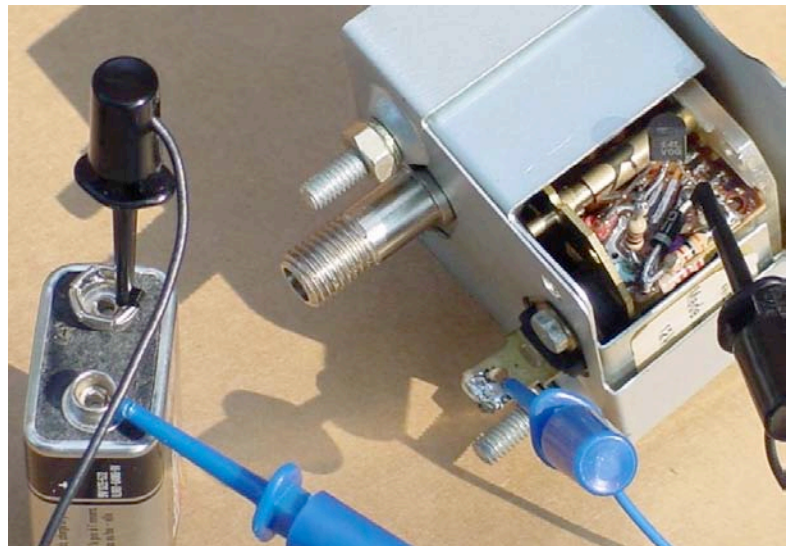
- With a battery clip, connect the 9V battery's + terminal to the clock's rear flat terminal and the 9V battery's – terminal to clock's metal housing.
- Note: one end of the clock's pendulum can be seen by looking under the metal cover shown in Picture 2 (look through the gap between the metal housing and the brass support post).

Picture 2: 9V battery test set up

- Refer back to Picture 2.
- Through a battery clip, connect the 9V battery's + terminal to the clock's rear flat terminal and the 9V battery's - terminal to clock's metal housing.
- Orient the clock as if the clock were installed in the vehicle to allow the escapement gear to work with gravity.
- The clock will be able to start on its own; if already started, deliberately stop the clock's pendulum with a toothpick near the center of its swing.
- The clock is "stalled" if one pulls the toothpick away without the pendulum moving.
- The newly installed transistor IC will make the pendulum wiggle 1 time per second.
- The new transistor IC will induce increasingly larger pendulum swings until operation resumes.
- It can take a few seconds to 1 minute to build up the energy needed to overcome any friction in the pendulum.

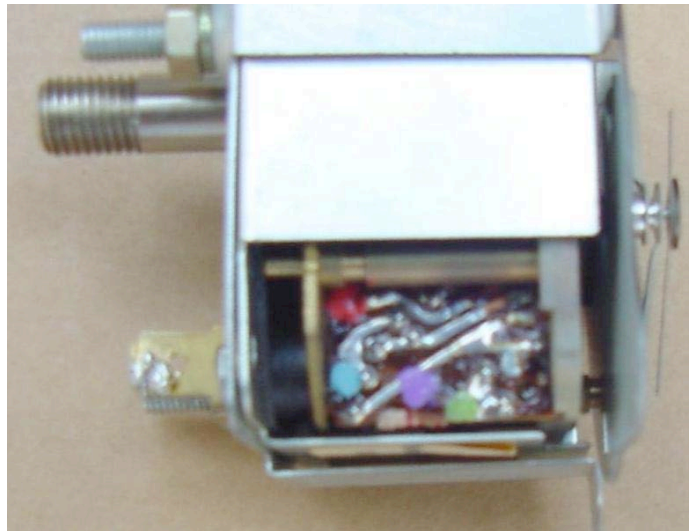
1. Using a paint pen, or colored finger nail polish, identify and mark the following circuit locations (or at least be familiar with these locations) as shown in Pictures 3 and 4.

2. The Green dot represents the clock's Ground (lower right most electrical connection on the clock's circuit board).
 3. The Purple dot represents the clock feedback bias (this appears as a diagonal circuit trace from the lower corner of the circuit board).

4. The Light Blue dot represents the clock's existing transistor's "emitter" (2nd electrical connection from the lower left corner of the clock's circuit board)—don't count the little hole in the circuit board trace.

5. Skip over the 3rd electrical connection from the lower left of the clock's circuit board (do not connect anything to this electrical location, its the Battery+ terminal).

6. The Red dot represents the clock's existing transistor's "collector" (4th electrical connection from the lower left corner of the clock's circuit board).

Picture 3: Location and marking the locations noted

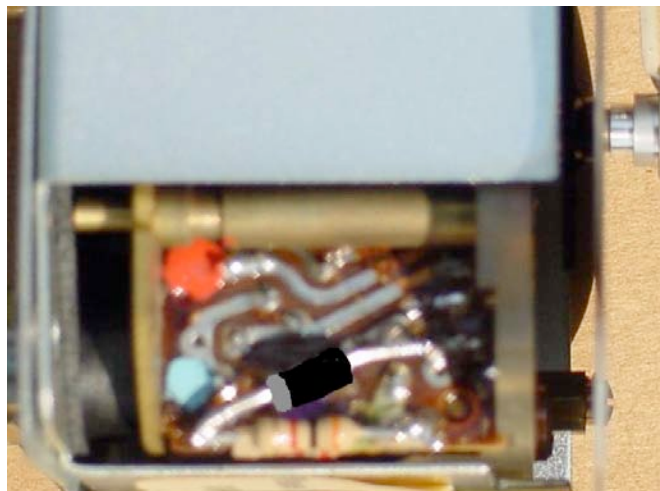
Picture 4: Temperature Compensation Diode and Resistor

7. Cut the leads from the 1N400x diode and 3.0K resistor so each lead length is 3mm.
 8. Using a Dremel Hobby Drill or Exacto Knife, cut the circuit board trace at the Purple dot's location.

9. Across this newly cut circuit trace, solder the 1N400x diode with the diode's anode band to the lower left corner as shown in Picture 4.
 10. The diode's anode (white or gray banding end of the diode's body) should be soldered to the existing solder pad in the circuit board's lower left corner and share one end of the 3.0K resistor. The other end of the 3.0K resistor should be soldered to the Green dot's circuit location.

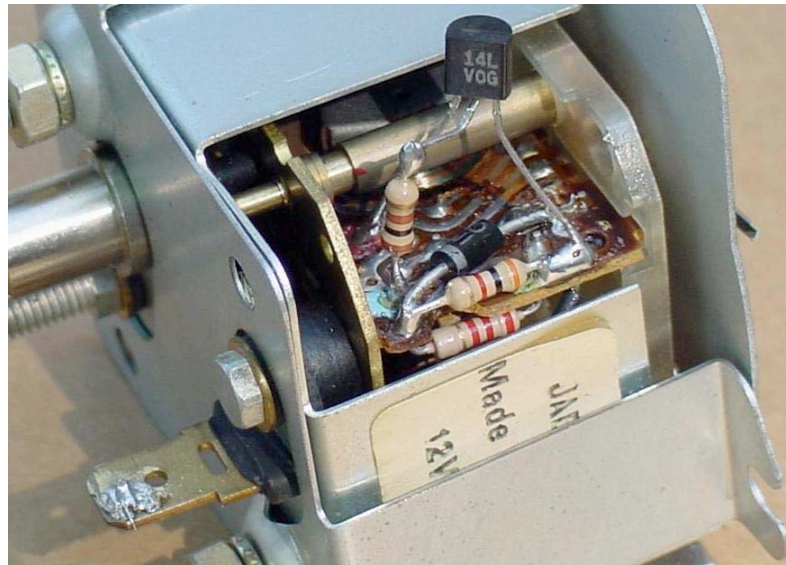
Picture 5: 14L transistor IC added

- Cut the leads from the 110 Ohm resistor so each lead length is 2mm.
- If 14L IC is being used, cut the center lead of the new 3 leaded transistor IC to half the length of the outer leads.
- Solder one end of the 110 Ohm resistor vertically to the Light Blue dot's circuit location. See Photo 5.
- Solder the "G" labeled lead from the new transistor IC to the Green dot's circuit location. See Photo 5.

- Solder the "V" labeled lead from the new transistor IC to the Red dot's circuit location. This is hidden by the 110 Ohm resistor in Photo 5.
- Solder the center lead of the new transistor IC to the unused end of the 110 Ohms resistor (the center lead is sometimes marked as "L", and sometimes mark "O" see Picture 5).
- Note: the new transistor IC will operate as the clock's "pace maker" or "watchdog timer".
- Verify the 3rd electrical connection from the lower left corner has nothing connected to it or touching it. If an accidental connection is made to this location, the components will "smoke" when powered and the clock's coil will become un-repairable (I learned from making this mistake).
