TECHNICAL SERVICE BULLETIN

Triumph

COOLANT LOSS

TR7

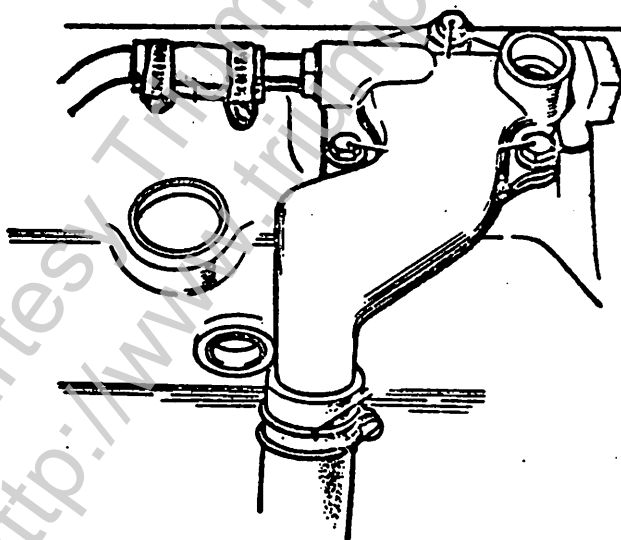
There is one hose connection located directly underneath the induction manifold (refer to diagram), which conceivably could be overlooked because of its location. Access to this hose is gained by reaching with a long screwdriver from the right hand side of the engine underneath the carburettors.

It is of particular importance during the pre-delivery service on the Triumph TR7 that all water hose connections are thoroughly tightened so as to prevent coolant loss.
