Replacing The TR7 Prop-shaft CV Boot

By Norm Hall

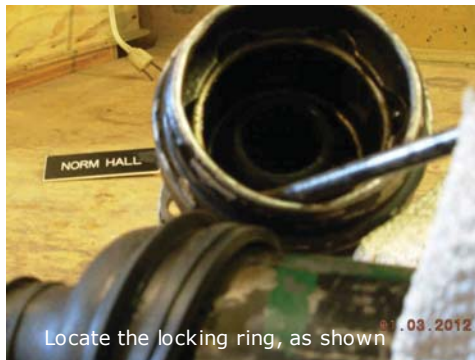
Locate the locking ring, as shown

Remove the locking ring / retaining spring from the CV carrier. The ring is shown in the photo below, after removal.

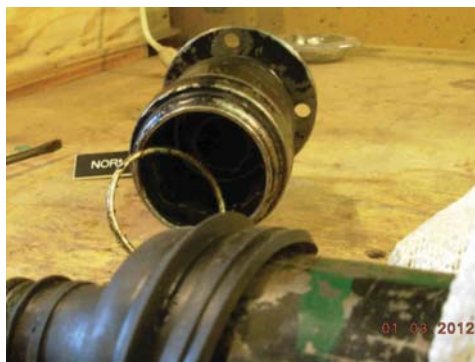
Locking ring removed from the CV joint, new boot installed

Place the new boot on the shaft by sliding it over the splined end. Tie the boot with the tie included in the boot kit, then turn the boot inside out over the shaft.

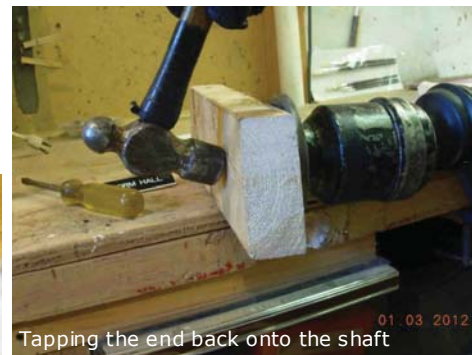
Tapping the end back onto the shaft

Place a block of wood on the mounting end of the CV carrier, and tap the carrier onto the shaft until it is fully seated. Depending on the shaft, this might require a bit more than a tap, but you want the carrier to seat against the rubber bumper that you noted previously before you removed the CV joint.

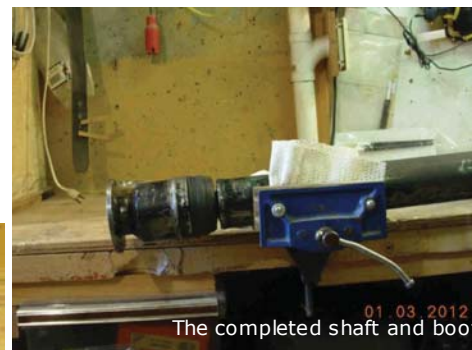
The completed shaft and boot

out, and attach it to the CV carrier with the tie supplied in the kit. That's all there is to it. While not difficult, it is something that can be tricky. To replace the boot, I used a kit for the Classic Mini. The kit is available from various vendors.

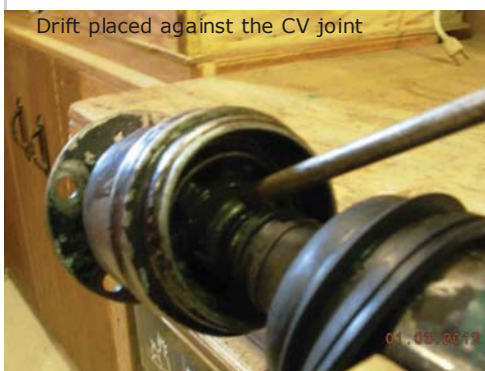
Drift placed against the CV joint

Place a blunt drift on the metal edge just in front of the rubber band noted above. Take a hammer, and drive the CV joint off the shaft. Once the CV joint is removed, look inside the joint and locate the retaining spring.
